# **Vulnerability of Vents to Wind-Blown Embers**

AUGUST 2017

Stephen L. Quarles, Ph.D.

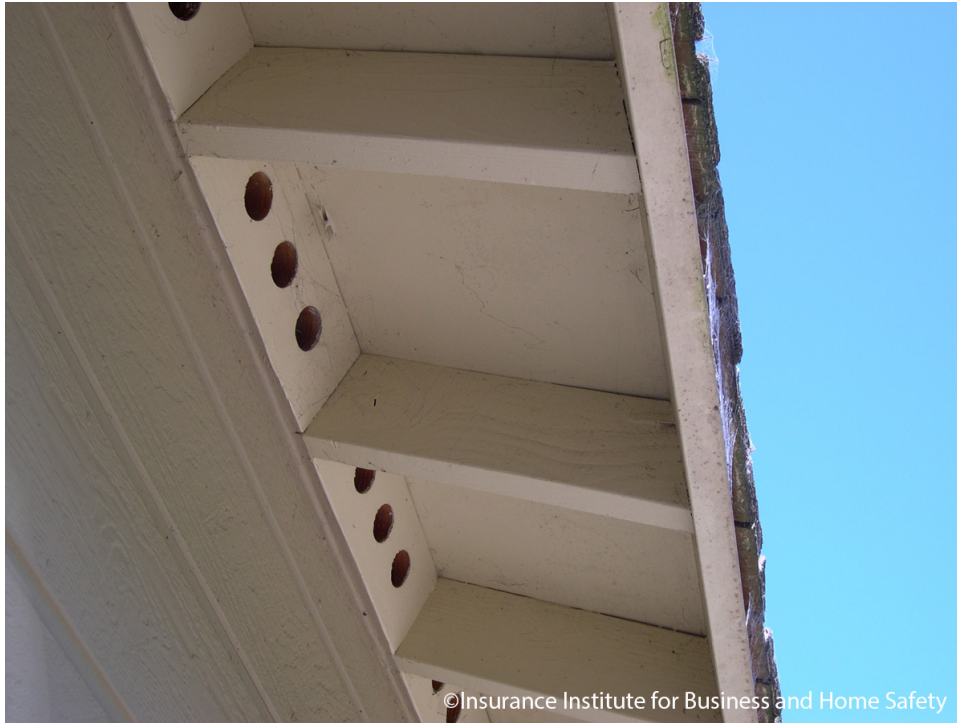
**Figure 1.** Vents located in between-rafter blocking in the under-eave area of a building that used open-eave construction.

Two types of under-eave (inlet air) vents were used. These included (1) open-eave vents that are incorporated into the solid-wood blocking inserted between roof rafters (or trusses), and (2) vents that are incorporated into the soffit material in “boxed-in” construction, as shown in Figures 1 and 2, respectively. A standard overhang width of 18 in. (460 mm) was used on all sides of the test building. An interior attic partition was constructed to separate the two inlet vent sections of the test building (i.e., the open-eave and soffit-eave sections) used for these experiments (Figure 3).

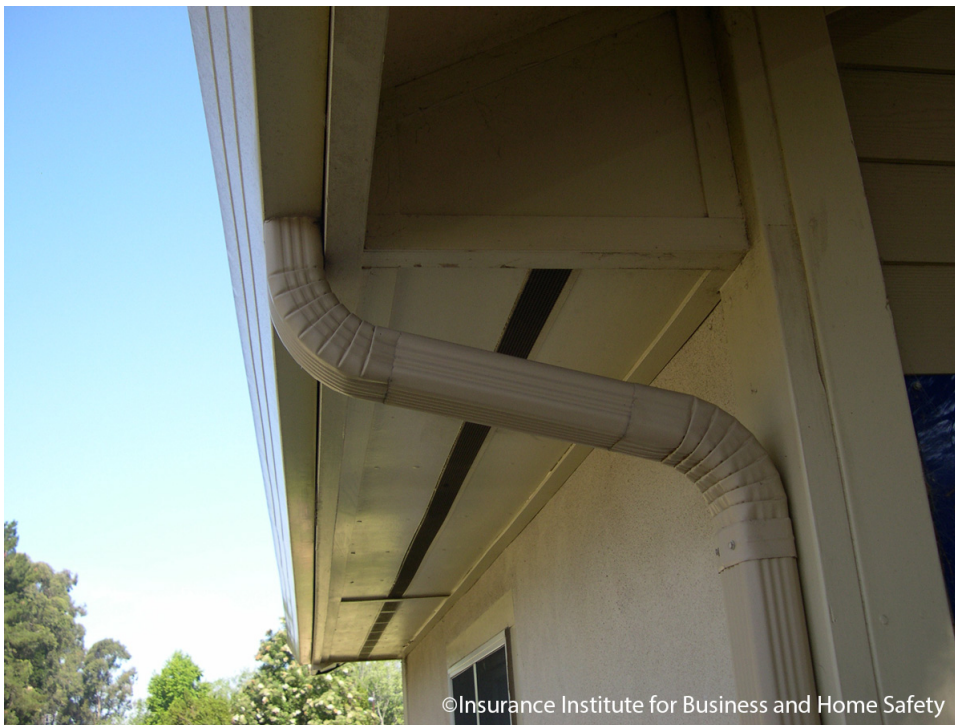
**Figure 2.** A strip vent located in the soffit of a building that used soffited-eave construction.

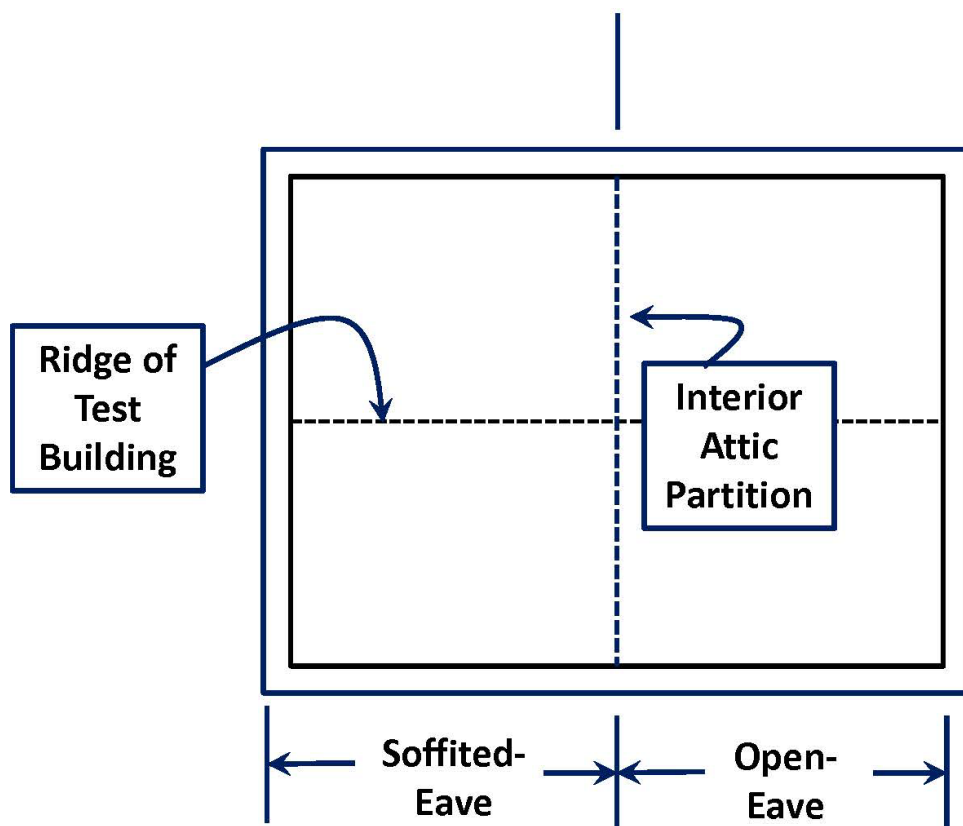
**Figure 3.** A plan view diagram of the test building showing the location of the two types of inlet (under-eave) vents used in this series of experiments.

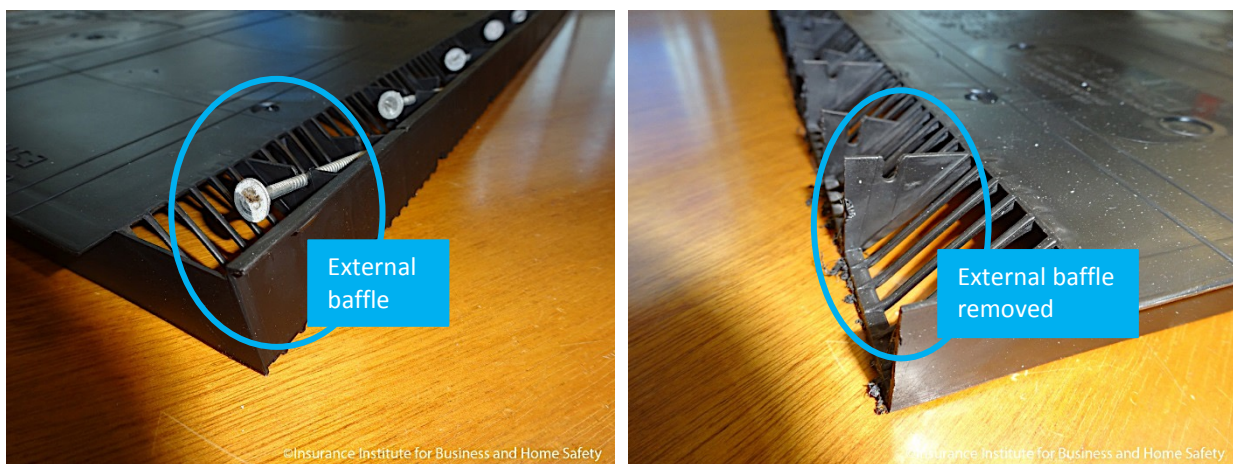
**Figure 4.** A Miami-Dade wind-driven-rain-compliant ridge vent (left) and the same vent modified by removing the external baffle (right).

2. **Off-ridge vent.** During these experiments, one of three different off-ridge vents were installed—a turbine vent, a flat-faced vent covered with  $\frac{1}{4}$ -in. diamond mesh screening, or an off-ridge California OSFM-accepted ember- and flame-resistant vent that incorporated a steel wool fill in the vent design.
3. **Ridge vent.** During these experiments, a Miami-Dade wind-driven-rain-rated vent (complying with Testing Application Standard [TAS] 100A), or this vent modified by removing the external baffle, was installed (Figure 4).

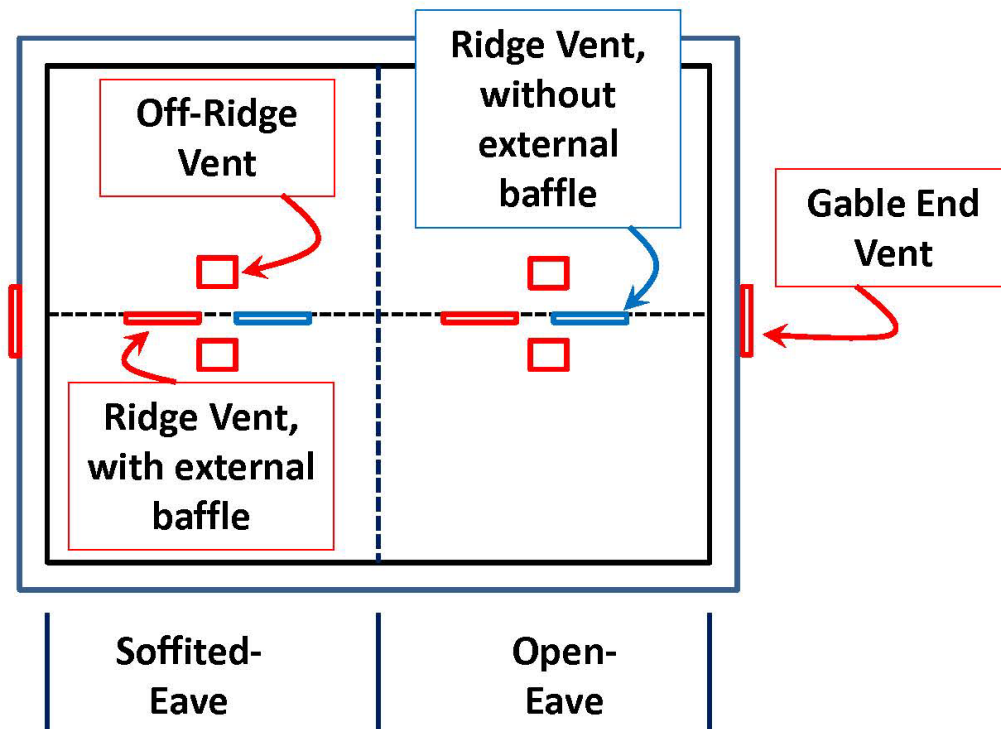
**Figure 5.** Locations of gable end, ridge, and off-ridge vents. Only one of these vent types was installed during a given experimental series.

A diagram showing the locations of the outlet vents is given in Figure 5. As indicated, only one outlet vent was used during any individual test.

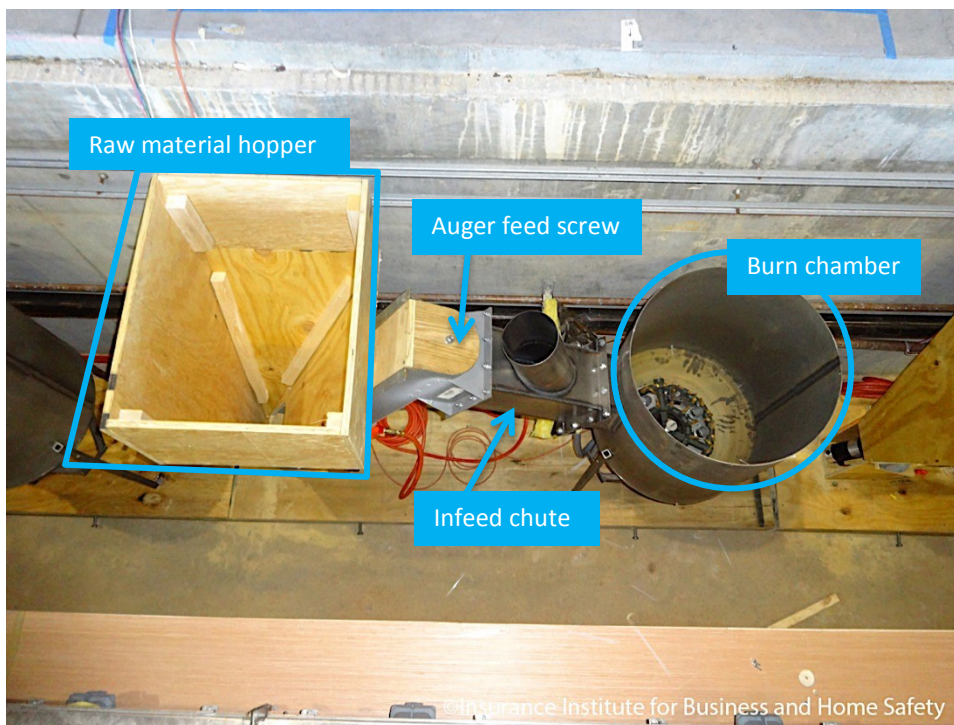
**Figure 8.** The ember generation system consisted of the raw material storage hopper (left) and a burn chamber (right). An auger feed screw delivered the raw material to the burn chamber through an in-feed chute. These components of the ember generation and delivery system were located below grade in a trench.

One of the seven ember generators used in this study is shown in Figure 8. Each generator consisted of a cylindrical burn chamber and a raw material hopper. An auger feed screw conveyed the wood-based feed stock for the generators out of the hopper and into a chute that dropped the feed stock onto a metal mesh screen positioned just above a natural gas burner located near the bottom of the burn chamber. The gas burner ignited the raw material that accumulated on the metal screen.

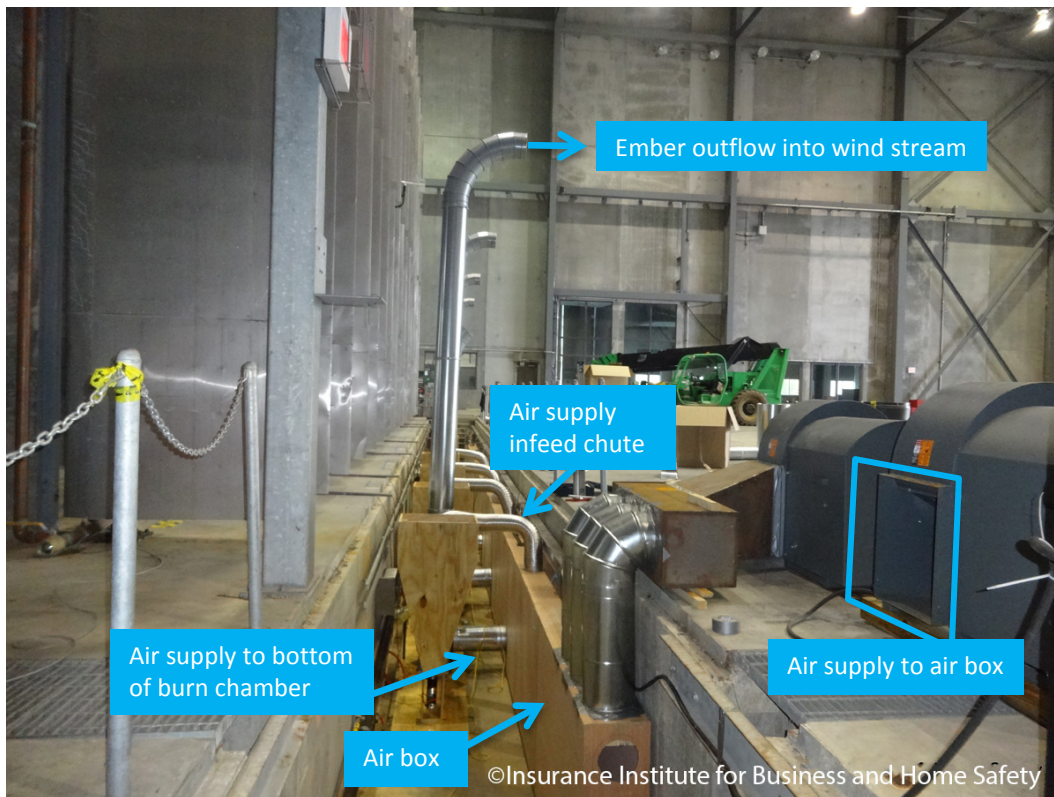
**Figure 9.** Overview of ember generation system. The charged air box supplied air to bottom of burn chamber (pushing lofting embers into vertical ducts and then into wind stream of wind tunnel fans) and to the top of the infeed chute (minimizing heat exchange between burn chamber and raw material hoppers).

An overview photograph of the seven ember generators is shown in Figure 9. This figure shows the vertical ducts that carry the burning (glowing) embers from the burn chamber into the wind stream of the test chamber. It also shows one-half of the air supply and distribution system used for the generators. Another air supply and distribution system was located on the opposite side of the chamber. The air supply system served two purposes: (1) to deliver air to an opening in the bottom of each generator, thereby providing the force needed to push the lofting embers out of the burn chamber and out of the vertical duct, and (2) to deliver air to the top of the infeed chute, which provided sufficient positive pressure to confine the fire to the burn chamber, and keep it from moving up the infeed chute and into the raw material hopper.

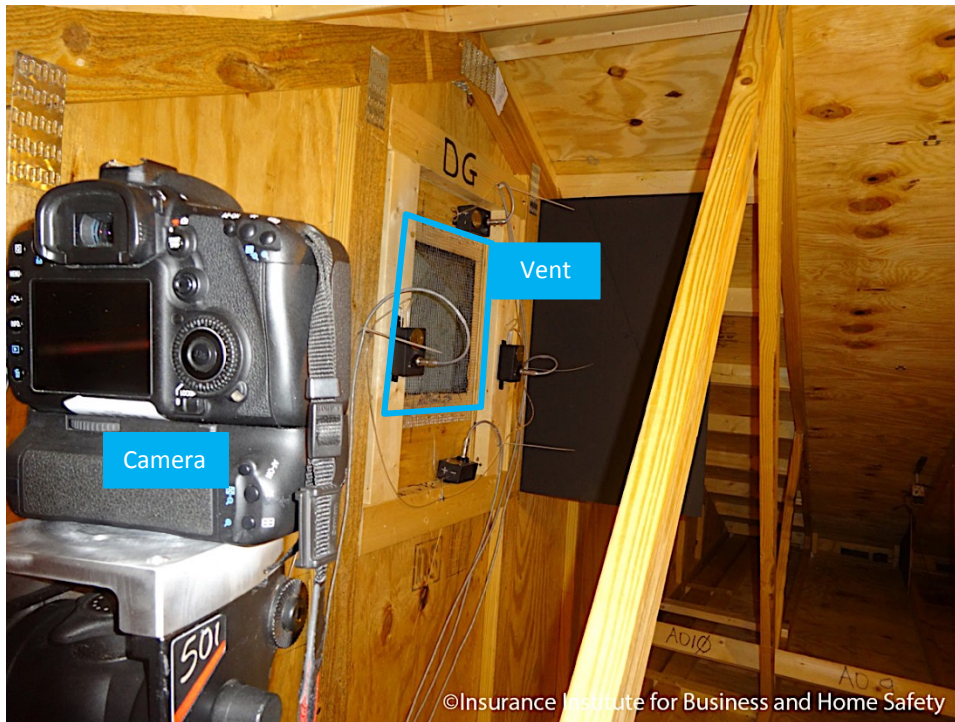
**Figure 11.** Typical video camera setup used to evaluate ember entry through the gable end vent.

Video- and non-video-based measurements were used to evaluate the ability of a given vent to resist the intrusion of wind-blown embers. For each test, cameras were positioned at interior location(s) to capture video of embers that entered through one or more vent openings. In the case of inlet (under-eave) vents, the field of view of a given video camera was sufficient to capture entry through two or three vent openings. For gable end and through-roof vents, cameras were only able to capture ember entry for an individual vent. A post-processing procedure using a particle tracking algorithm was used to count embers. Typical camera setups are shown in Figures 11 and 12.

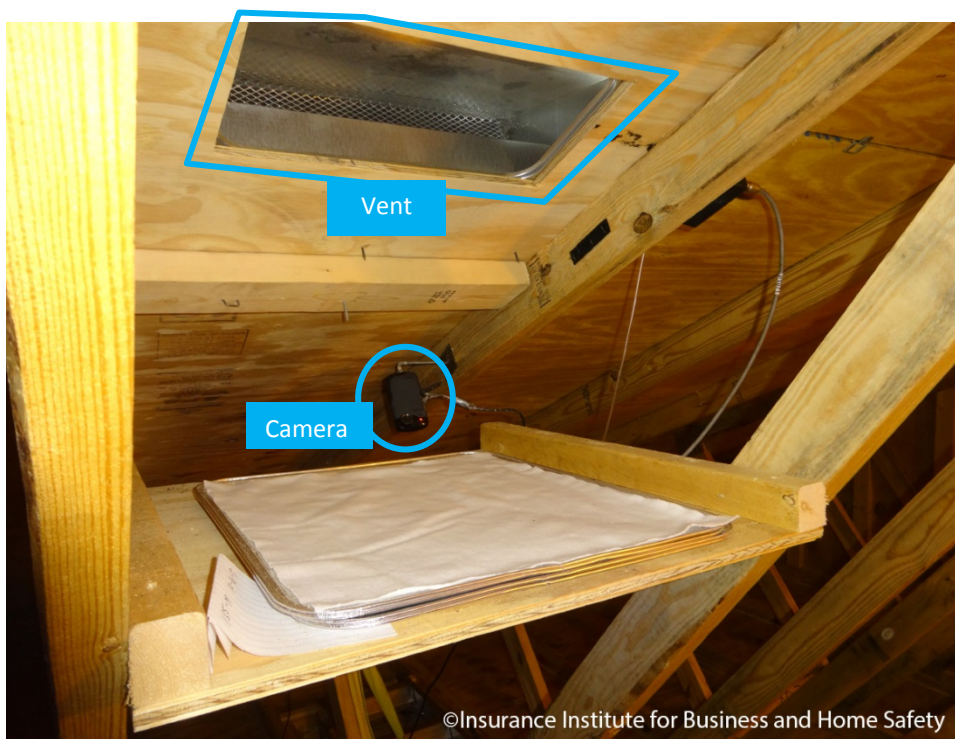
**Figure 12.** Typical video camera setup used to evaluate ember entry into a through-roof vent.

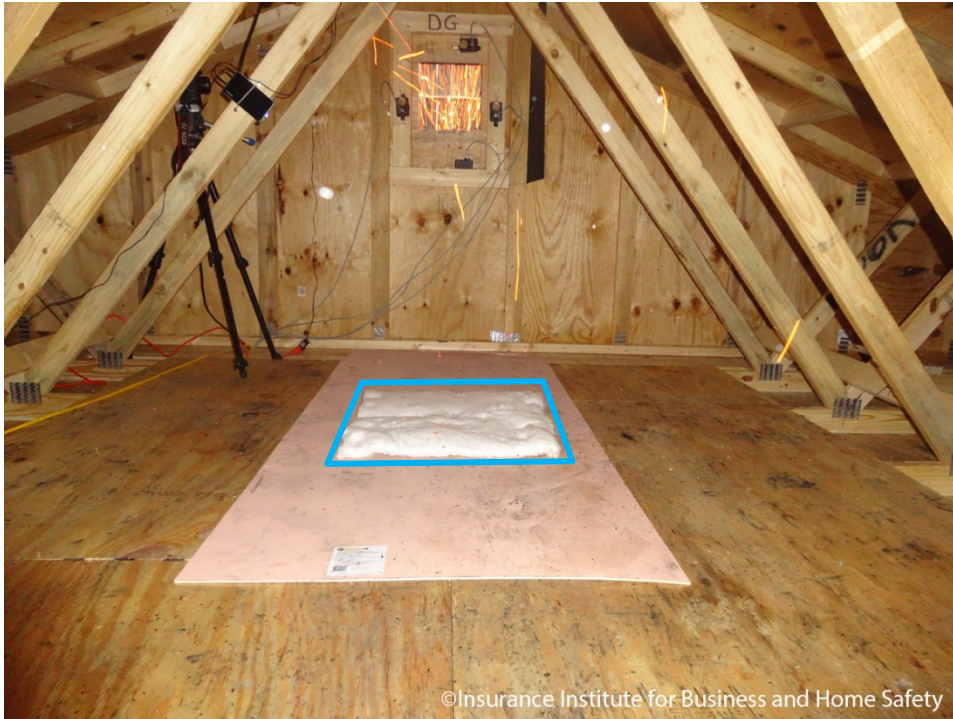
**Figure 14.** A cotton pad was placed on a horizontal surface, near the entrance of gable end and all through-roof vents to evaluate the ability of entering embers to ignite a combustible material.

During gable end and through-roof vents tests, a cotton pad was placed on a horizontal surface near (under) the entry area for the vent. In the case of the gable end vent, the cotton was placed on the panel previously mentioned (Figure 14). In the case of other through-roof vents, the cotton was placed on an elevated platform (Figure 12). The cotton was used to evaluate the ability of embers to ignite fine fuels in an attic space. Cotton served as a surrogate for all combustible fine fuels that could be in an attic space. Cotton was selected because it was the combustible materials selected for use in the ASTM standard test method to evaluate the performance of vents (ASTM E2886). Cotton is also used in other ASTM fire test standards. This standard evaluates vent performance by evaluating the ability of embers that pass through a given vent to ignite the cotton substrate.

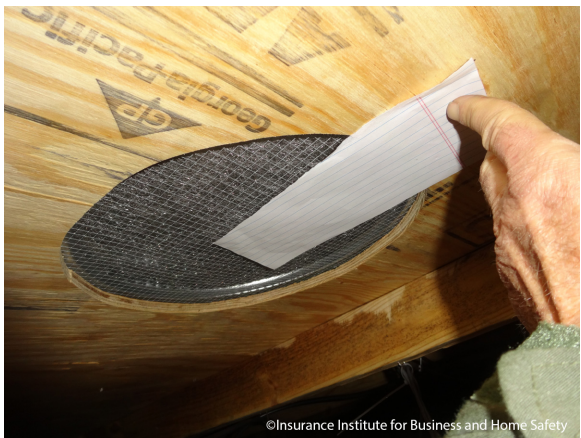
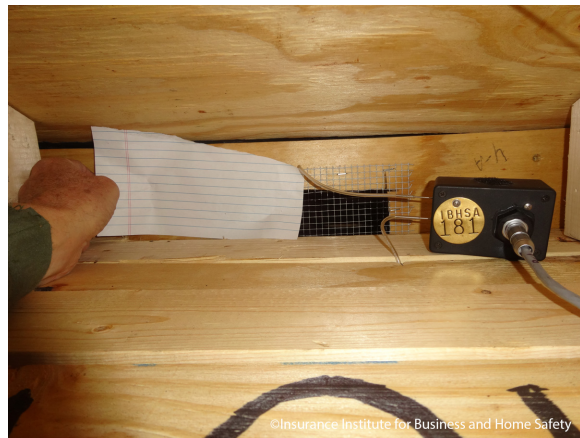
**Figure 16.** As indicated by the action of the ribbons, on the leeward side of the building, the off-ridge through-roof vent (left) and open-eave vent (right) were outlet vents.

Vents are designated “inlet” or “outlet” vents based on air flow into and out of the attic space under natural convection conditions. Under the elevated wind speed scenarios used in this tests (and typically present during wildfires), all under-eave and the non-turbine off-ridge vents on the windward side of the building were inlet vents (Figure 15), and those on the leeward side of the building were outlet vents (Figure 16), regardless of their nominal designation. The ridge (Miami-Dade-compliant and non-Miami-Dade-complaint) and turbine vents were consistently outlet vents (Figure 17).

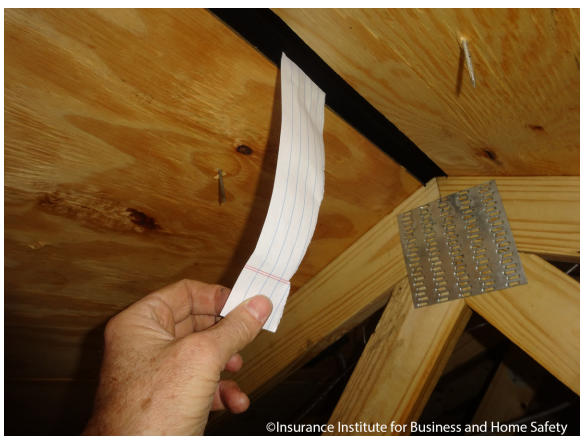
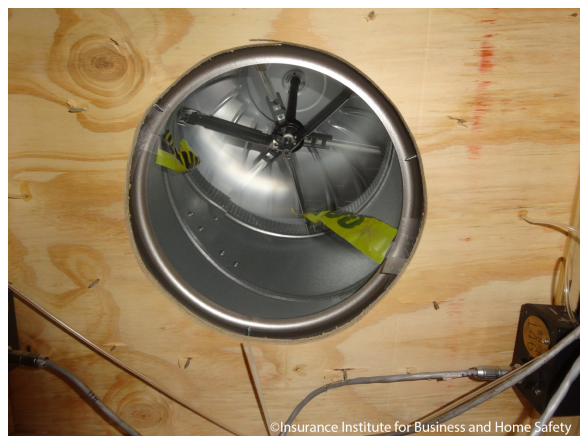
**Figure 17.** As indicated by the action of the ribbons, the ridge vent (left) and turbine vent (right) were consistently outlet vents.

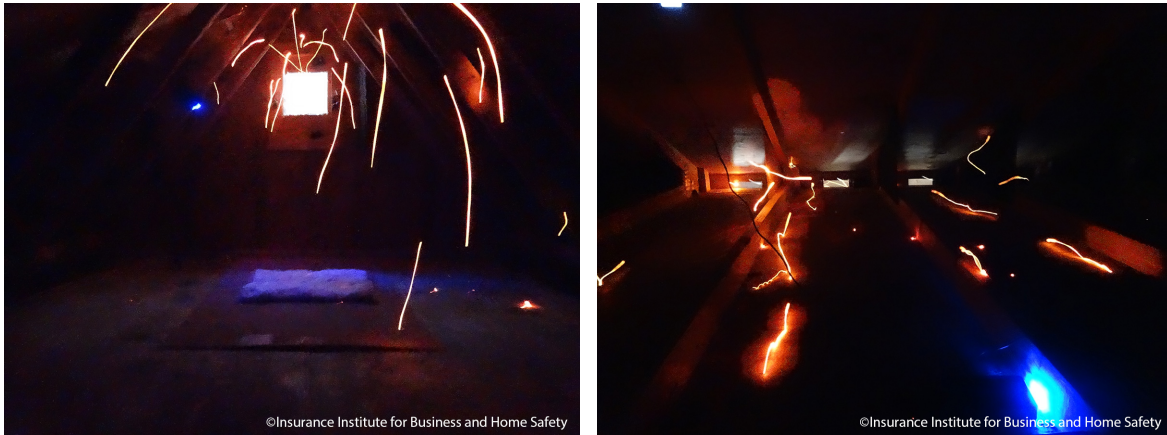
**Figure 20.** The bright streaks are embers that entered the attic space through a gable end vent (left) and vents in open-eave blocking (right). They did not congregate in any concentrated area on the attic floor.
